A simulated bushfire test report

Test standard: Clauses 14 and 22 of AS 1530.8.1:2018

Product: FLAMEfixx® subfloor system

Bushfire attack level (BAL) exposure: 40 kW/m² Crib class: AA

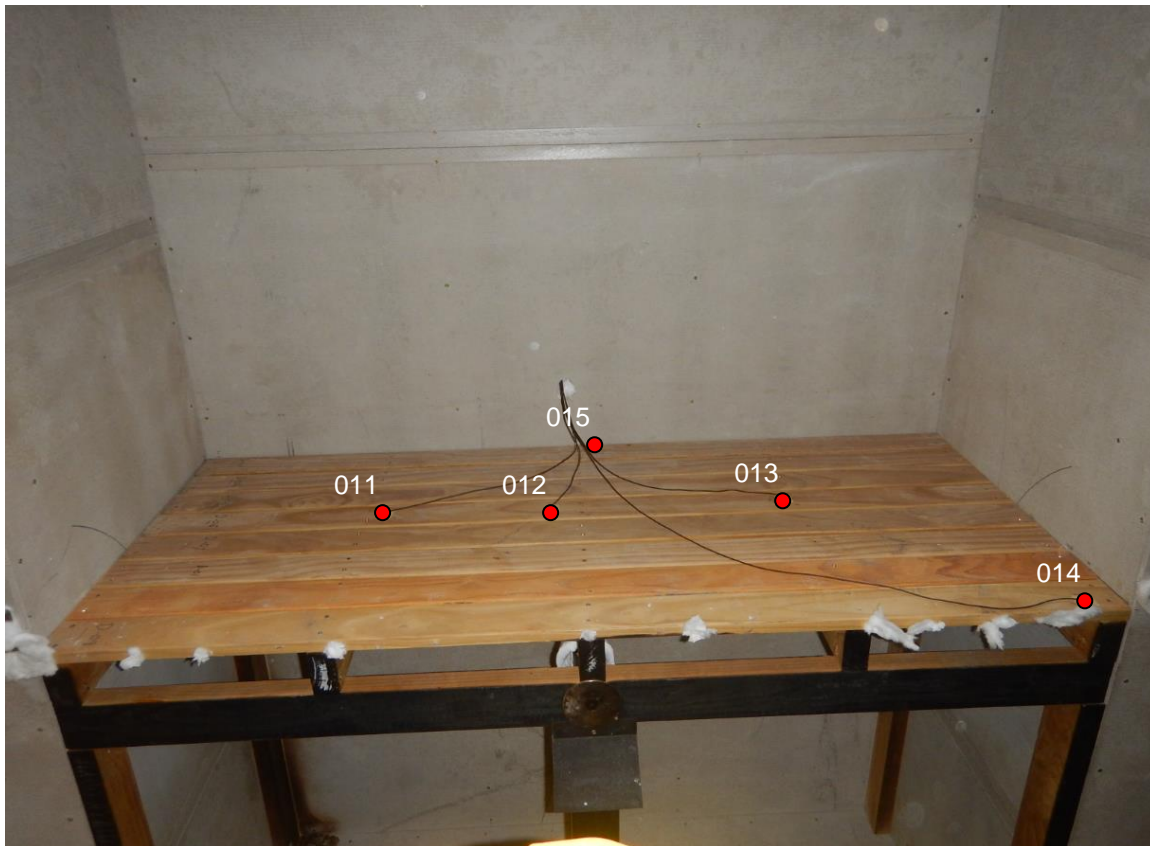
- Red dots show unexposed thermocouple locations.

Figure 4 Instrumentation locations (unexposed side shown)

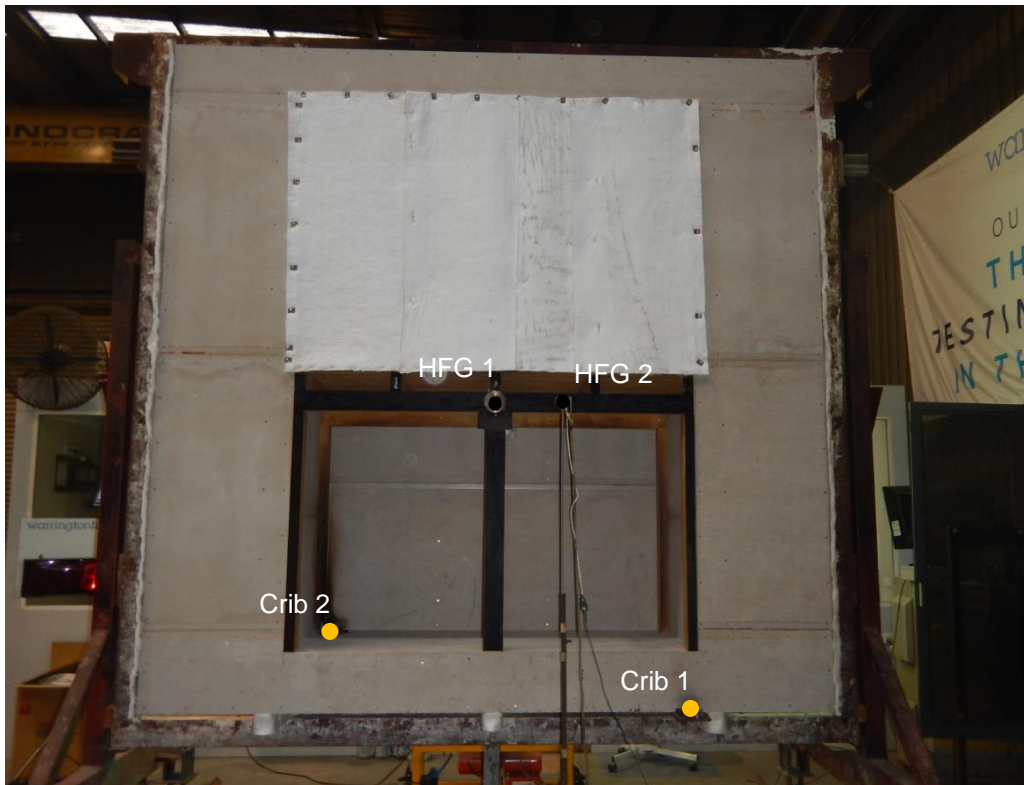
- Southern crib located at the base of the wall below the south front stump
- Northern crib located below the subfloor adjacent to the south rear stump
- Black dots show heat flux gauge locations.
- Orange dots show crib locations.

Figure 5 Instrumentation locations (exposed side shown)

Start of the test	22 °C	Minimum temperature	22 °C	Maximum temperature	38 °C
Start of the test	22 °C						
Minimum temperature	22 °C						
Maximum temperature	38 °C						
Test duration	The test was stopped after 60 minutes in accordance with the procedures in AS 1530.8.1:2018.						
Instrumentation and equipment	<p>The instrumentation was provided in accordance with AS 1530.8.1:2018 as follows:</p> <ul style="list-style-type: none"> The unexposed side specimen temperatures were measured by Type K thermocouples with wire diameters less than 0.5 mm soldered to 12 mm diameter x 0.2 mm thick copper discs covered by 30 mm x 30 mm x 2.0 mm thick inorganic insulating pads. The thermocouple positions are shown in Table 10 and in Figure 5 in Appendix D. A Ø3 mm gap gauge was available during the test to assess the performance of the specimen under the criteria of integrity. A pilot ignition source was available to assess any areas of the specimen producing significant quantities of volatiles. The crib was conditioned for at least 24 hours in a conditioning oven and removed 1 hour before the start of the test. The crib was weighed to confirm that it was within the 0.152 ± 0.03 kg mass required by the standard. The crib was lit over a 2 minute period – 20 seconds on the upper 0.10 m x 0.10 m face. 20 seconds on each of the 0.54 m x 0.10 m faces, and a further 20 seconds on the upper 0.10 m x 0.10 m face – using an oxyacetylene torch with Type 551 size 8 x 10 heating tip. Radiant heat flux measurements – to determine the irradiance received and transmitted from the exposed face of the specimen – were taken using Medtherm heat flux gauges. The irradiance received at the front of the subfloor system was measured by a heat flux meter for the radiant exposure portion of this test. During the test a second heat flux gauge were centrally located next to the subfloor at a distance of 250 mm from the exposed side of the specimen during the 20 to 60 minutes periods of the test. The heat flux gauge positions are shown in Figure 4 in Appendix E.

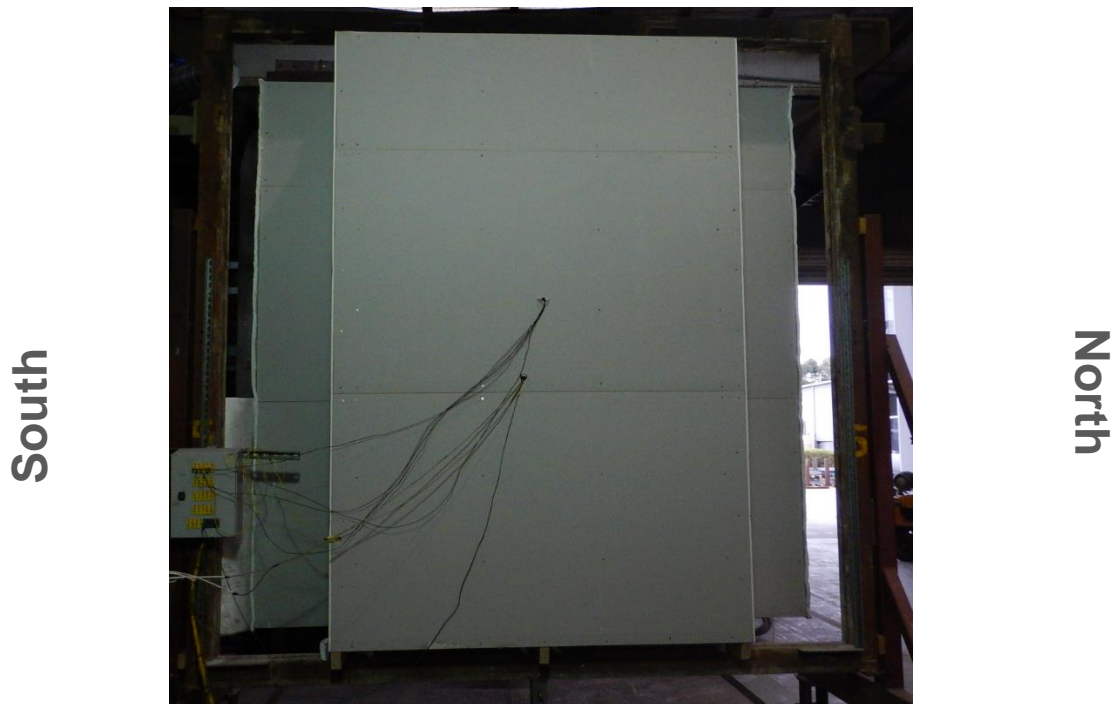
Figure 9 Unexposed face of the specimen before the start of the test

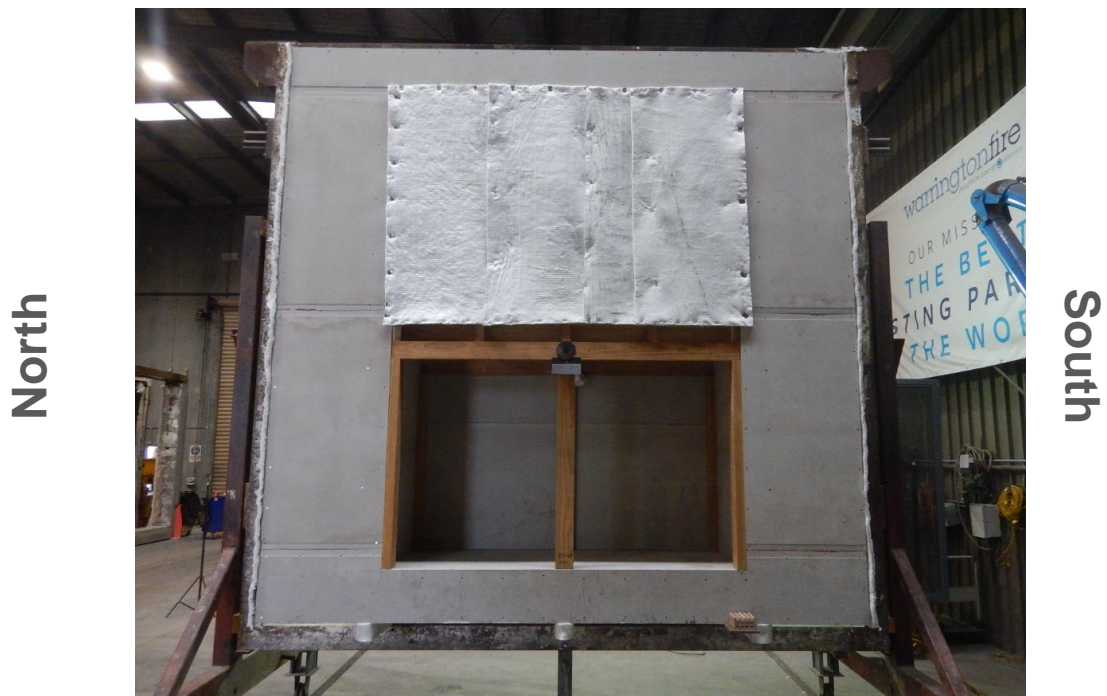
Figure 10 Exposed face of the specimen before the start of the test

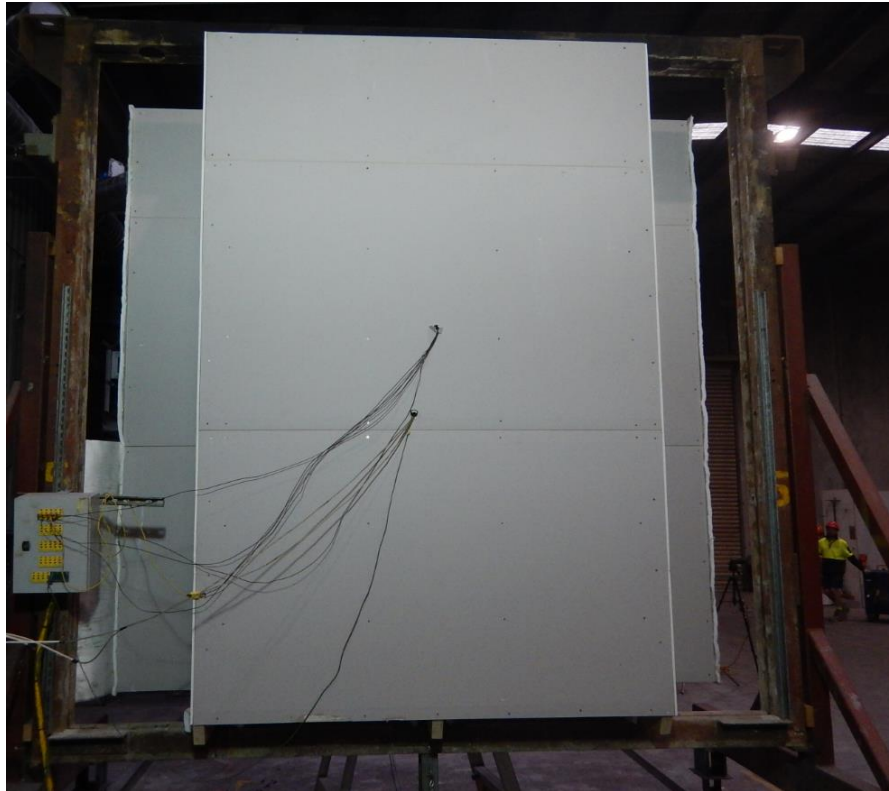
Figure 11 Unexposed face of the specimen at the end of the test

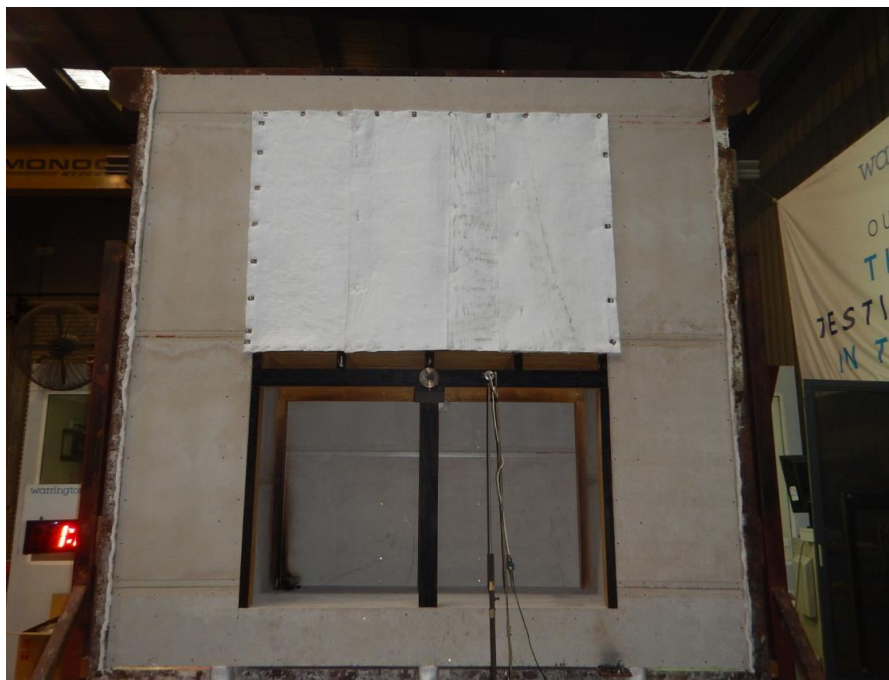
Figure 12 Exposed face of the specimen at the end of the test
