A simulated bushfire test report

Test standard: Clauses 14 and 21 of AS 1530.8.1:2018 Test sponsor: Wood Modification Technologies Limited Product: FLAMEfixx dFx® decking system Bushfire attack level (BAL) exposure: 40 kW/m² Crib class: AA Job number: FRT210169 Test date: 25 August 2021 Revision: R1.0

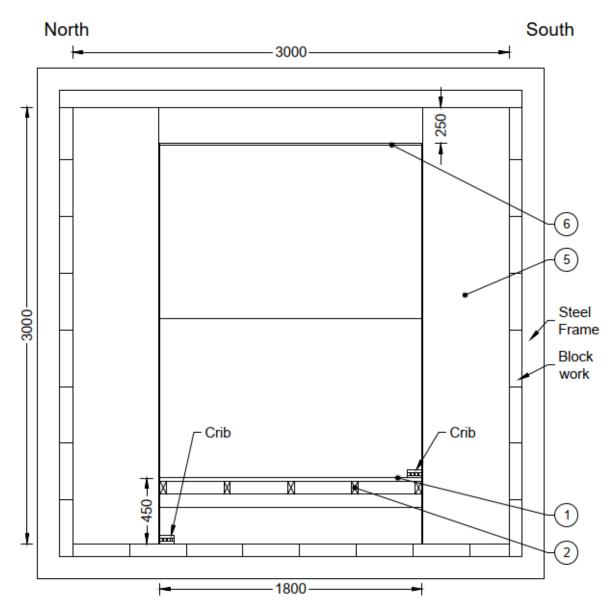
Figure 1 Elevation of the specimen

The leaders in the drawings represent the items listed in section 2.1. All measurements are in millimetres – unless otherwise indicated.

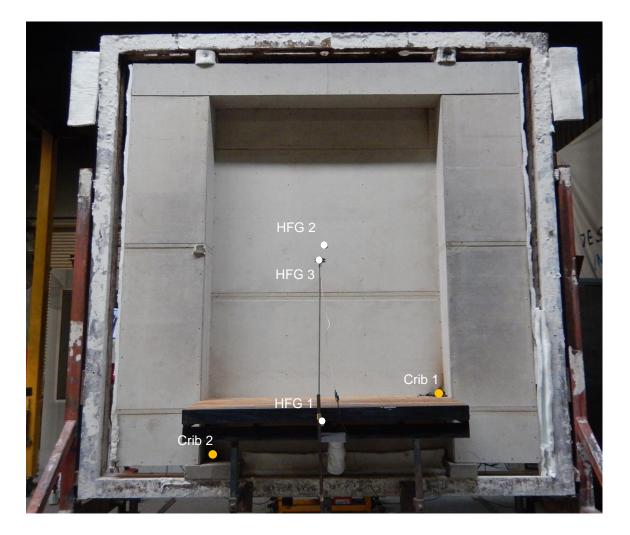
- Southern crib located above the deck
- Northern crib located below
- White dots show heat flux gauge locations.
- Orange dots show crib locations.

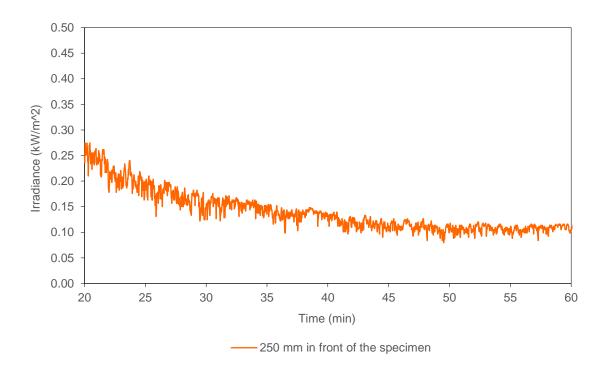
Figure 7 Radiant heat flux received 250 mm in front of the specimen

Less than 0.27 kW/m² heat flux radiation was received by the heat flux gauge positioned centrally to the front of the specimen and 250 mm from the wall during the time period of 20 to 60 minutes of the test period.
